Supplementary Guidance

Distribution Businesses Emergency Codes Explained

This resource supplements the associated document: Guidance on reporting issues found with Distribution Businesses (DB) service equipment. When reporting issues with DB equipment you should use it to ensure the issues you encounter are reported correctly.

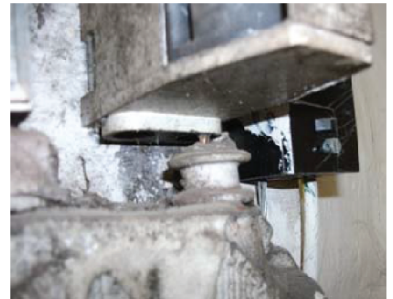
Visible bare wires

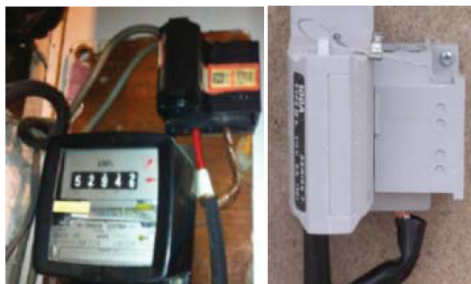
Exposed neutral conductors
